NWC TP 5812

Baseline Data From an A-4 Cockpit in Simulated Carrier Deck Fire

by
Anthony San Miguel
Systems Development Department

AUGUST 1976

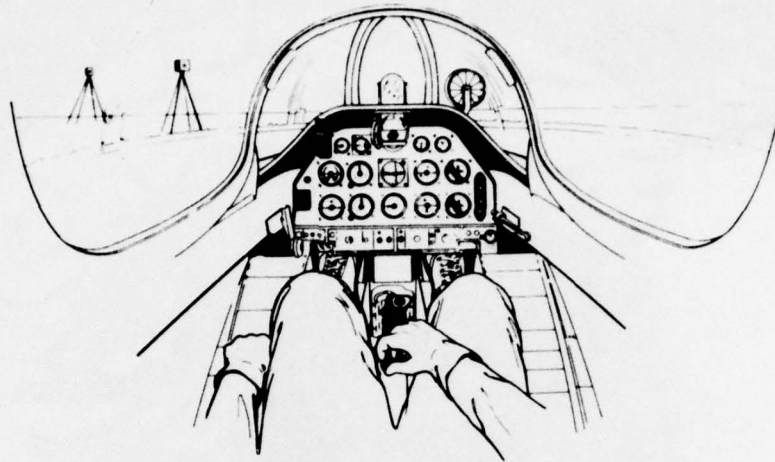
FIGURE 1(a). Conditions That Would Be Seen by Pilot at Ignition ($t = 0$).

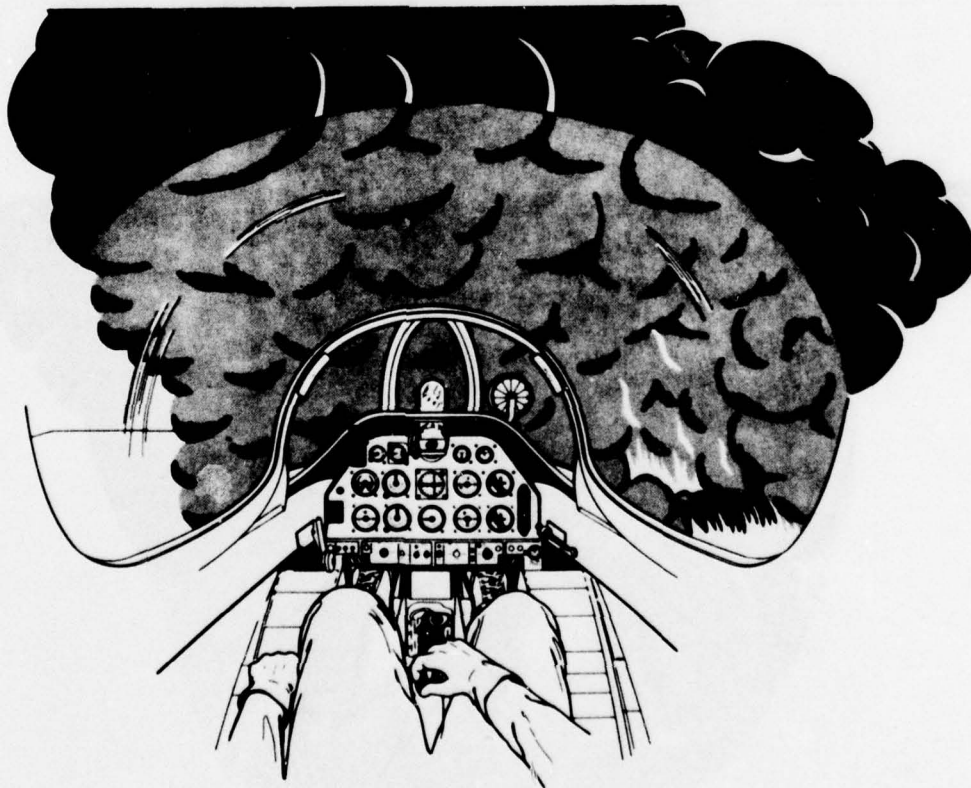
FIGURE 1(b). Eleven Seconds After Ignition ($t = 11$ Seconds).

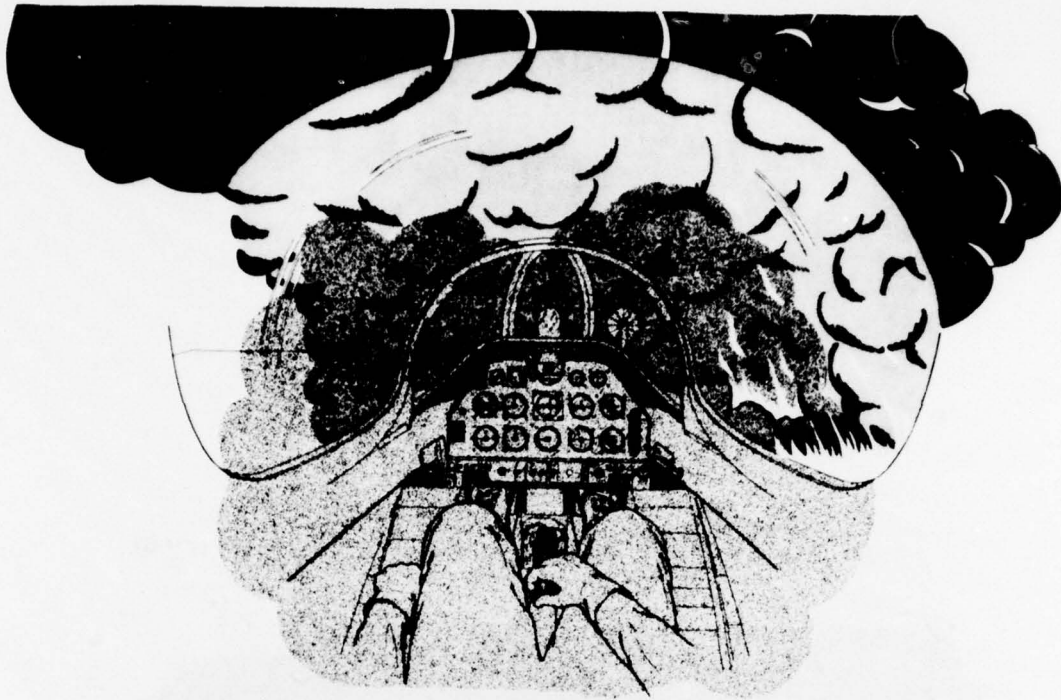
FIGURE 1(c). After 71 Seconds ($t = 71$ Seconds).

The activity of the cockpit mouse was recorded on movie film until it could no longer be observed at 71 seconds.¹ (See Figure 1(c), p. 8.) By the time the firefighters reached the cockpit after the fire, the mouse had died in the fire.

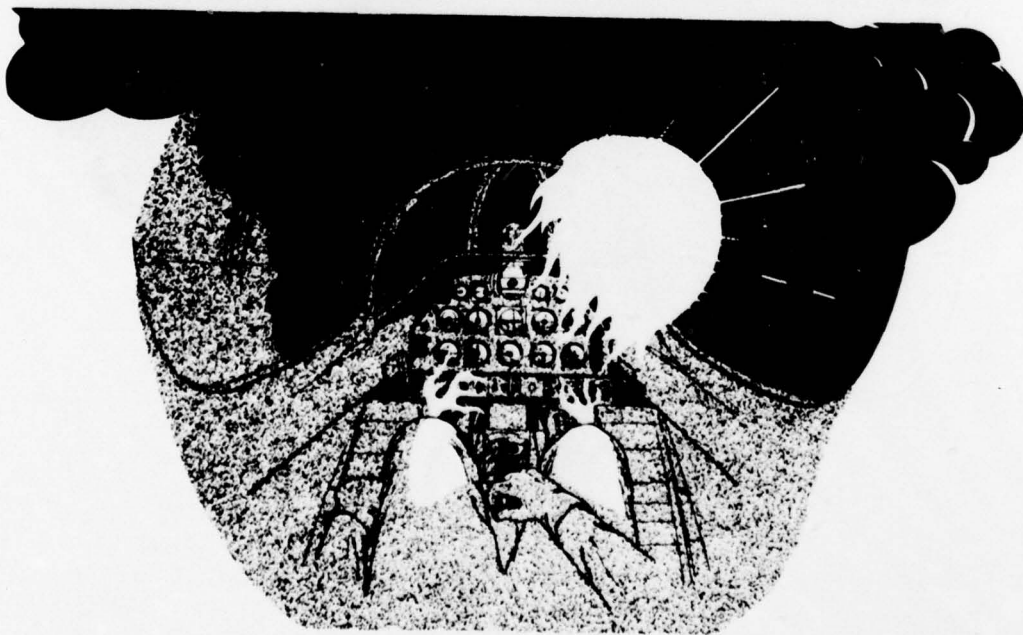
The cockpit heated faster on the starboard side due to the prevailing wind direction. First flicks of flame were seen in the cockpit at about 192 seconds. By about 222 seconds, the canopy had completely failed, and flames engulfed the cockpit. Calorimeter data indicated that the first significant heating in the cockpit came from the direction of the canopy at about 203 seconds (Appendix E). Next, a relatively hot burst came from below at 208 seconds. The entire region where the directional calorimeter was located was heated between 213 and 232 seconds. By 232 seconds, light water applied by firemen had cooled the interior of the cockpit.

FIGURE 1(d). Between 192 and 232 Seconds ($t = 192-232$ Seconds).

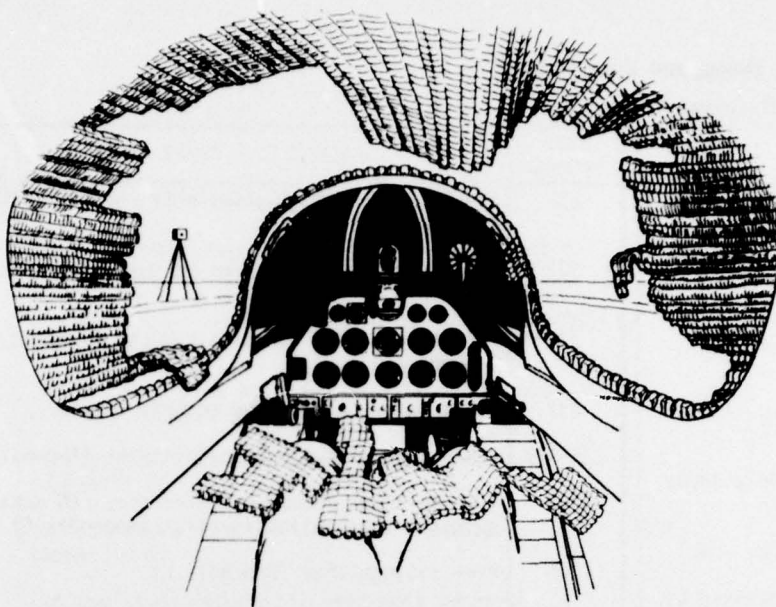
FIGURE 1(e). After Fire was Extinguished ($t = 243$ Seconds).

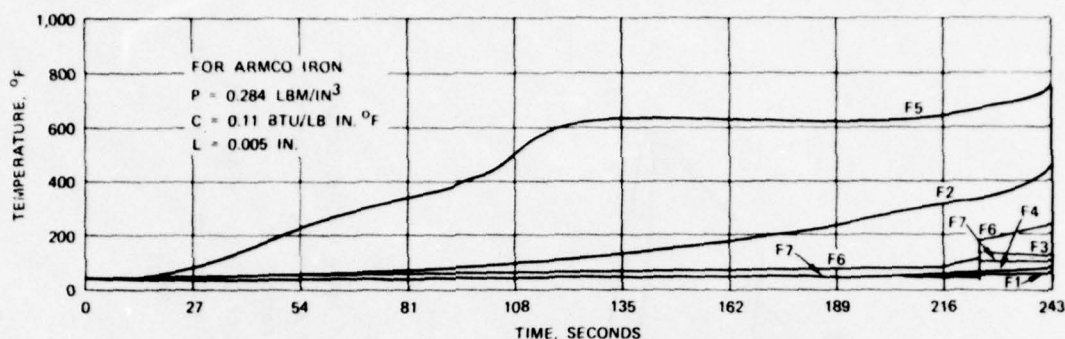
FIGURE E-4. Mean Temperature Change of Slug Calorimeters.

An overview of Figure E-4 shows that the interior of the cockpit was not being significantly heated during the test, with the exception of F5. The maximum heating-- $q < 0.15 \text{ BTU/ft}^2\text{-sec}$ (1702 W/m^2)--occurred on the starboard side of the aircraft as shown by transducer F5. That the heating of the cockpit was not symmetric is demonstrated in that F2 heated more slowly-- $q < 0.05 \text{ BTU/ft}^2\text{-sec}$ (567 W/m^2)--than F5. F2 sensed initial heating at 59 seconds. At about 185 seconds the heating rate increased to that initially experienced by F5. F5 sensed heat at 11 seconds and was saturated at 123 seconds. The saturation time suggests steady-state heating of the starboard interior side of the cockpit between 123 and 210 seconds. The increase in cockpit heating after 210 seconds is due to heat entering the cockpit via cracks in the cockpit and not because of the fire getting hotter.

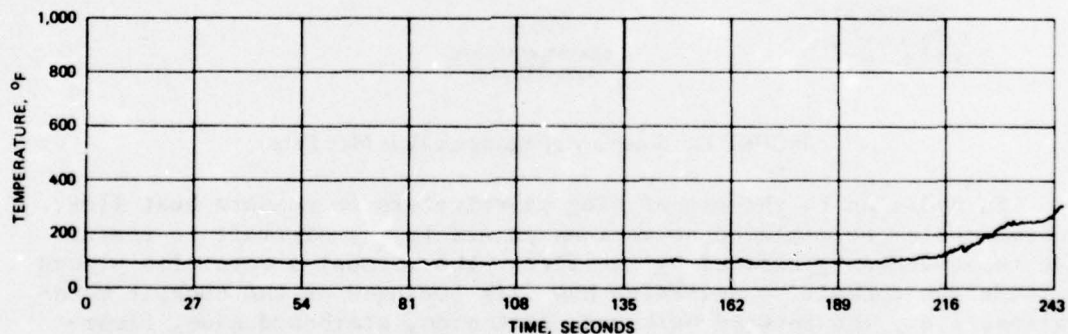
The typical response of a thermocouple sensing the temperature rise of all slugs in the three-dimensional transducer is shown in Figure E-5. The essential feature is that no significant heat is observed until about 205 seconds. The face of the transducer viewing the forward instrument panel sensed a heat rate of $0.46 \text{ BTU/ft}^2\text{-sec}$ (5221 W/m^2) between 213 and 222 seconds. The port and starboard faces recorded only about $0.022 \text{ BTU/ft}^2\text{-sec}$ (250 W/m^2) between 211 and 231 seconds. The bottom face measured about $0.94 \text{ BTU/ft}^2\text{-sec}$ ($10,700 \text{ W/m}^2$) between 208 and 232 seconds and the top face measured about $0.32 \text{ BTU/ft}^2\text{-sec}$ (3600 W/m^2) between 203 and 232 seconds. These data are summarized in Figure E-6. They suggest that initial significant heating came from the canopy region first (203 seconds). Next a relatively hot burst came from below at 208 seconds. The entire region where the three-dimensional transducer was located was heated during the period from 213 to 232 seconds. By 232 seconds, light water from the firefighting equipment had cooled the interior of the cockpit.

FIGURE E-5. Typical Response of Thermocouple Sensing Temperature Rise of Slugs in Three-Dimensional Transducer.

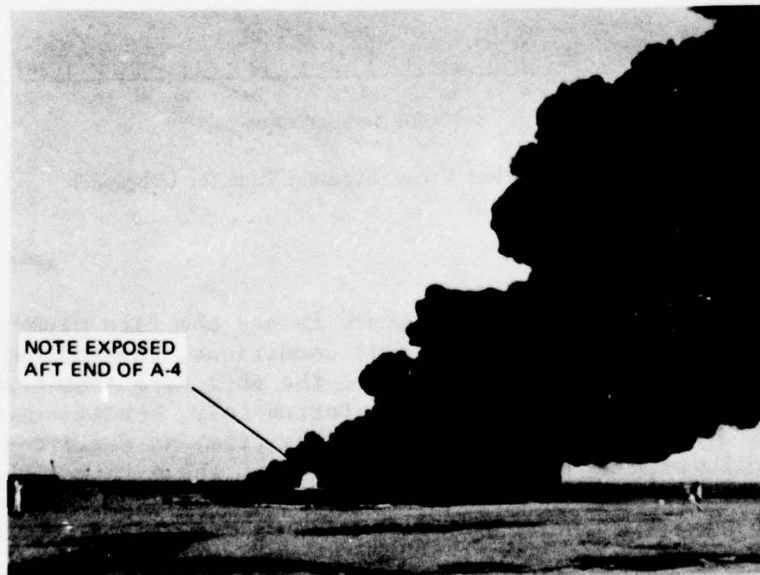
As discussed earlier, wind and gusts caused the fire plume to be deflected as shown in Figure E-9. These conditions, together with the protective effect of the wings, prevented the pool fire from heating the insulated aft portion of the aircraft. Fortunately, conditions were such that the cockpit section was engulfed by fire, as confirmed by the movie camera within the manikin. Unfortunately, the external thermocouple data was lost (due to recorder power failure), and hence flame characterization could not be evaluated since there was no telemetry backup.

FIGURE E-9. A-4 Pool Fire Deflected by Prevailing Wind. (Neg. LHL 187354)

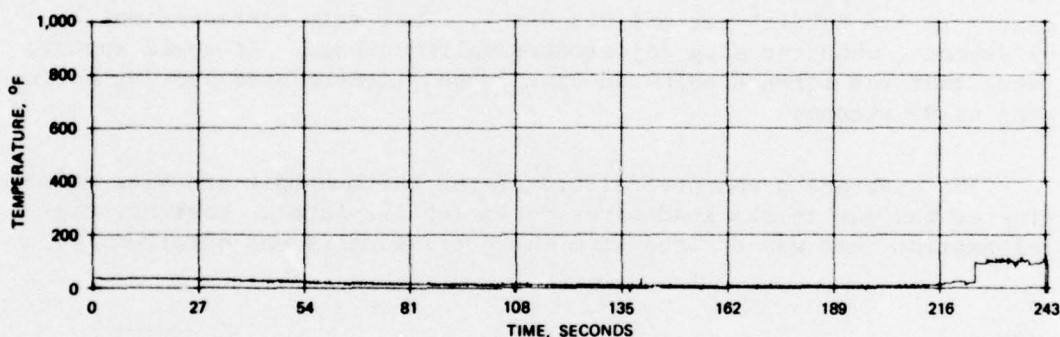
A slug calorimeter was placed on the back of the seat facing aft to detect potential heating from the fuselage fuel tank. Its output is shown in Figure E-10. No appreciable heating was recorded before the canopy failed.

FIGURE E-10. Output of Slug Calorimeter Placed on Back of Pilot's Seat, Facing Aft.

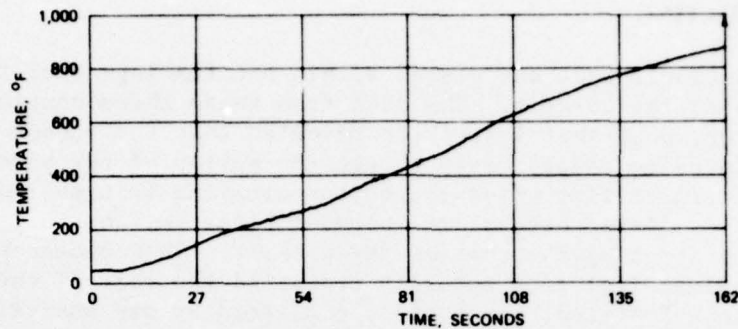
The response of the thermocouple is shown in Figure E-11. Initial heating was detected at 7.4 seconds after ignition. Heating remained relatively uniform until 162 seconds, at which time the thermocouple failed, perhaps suggesting that the nose cone was destroyed by fire or mechanically detached.

FIGURE E-11. Output of Thermocouple Located 1 Foot (0.3 m) in Front of Bulkhead Hinge in Nose Cone.

The apparent premature failure of the thermocouple and slug calorimeter was due to the lead wires not being insulated. However, the information that was desired from these transducers was obtained.

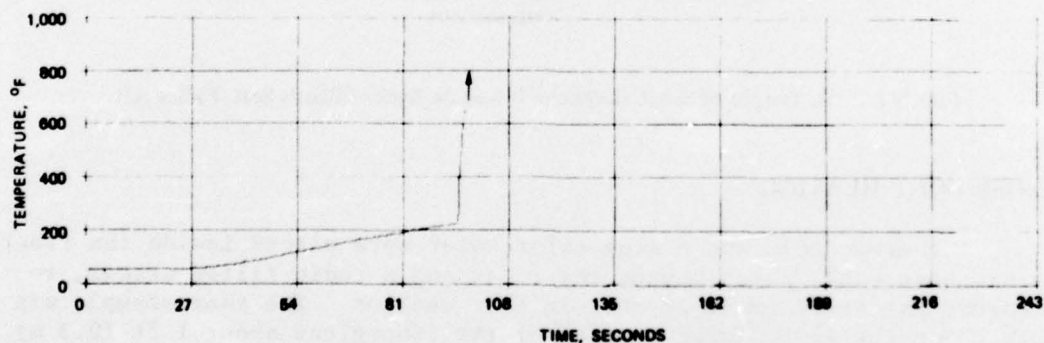
The slug calorimeter response is shown in Figure E-12. Initial heating was detected at 21 seconds. The heating rate was about $0.05 \text{ BTU/ft}^2\text{-sec}$ (567 W/m^2). At 95 seconds the heating rate increased significantly to $4.5 \text{ BTU/ft}^2\text{-sec}$ ($51,048 \text{ W/m}^2$). That rate continued until 99 seconds, when the slug calorimeter malfunctioned. It would appear, then, that the forward bulkhead experienced fire-related heating beginning at 95 seconds.

FIGURE E-12. Output of Slug Calorimeter Placed on Radio Access Filter Screen in Nose Cone.

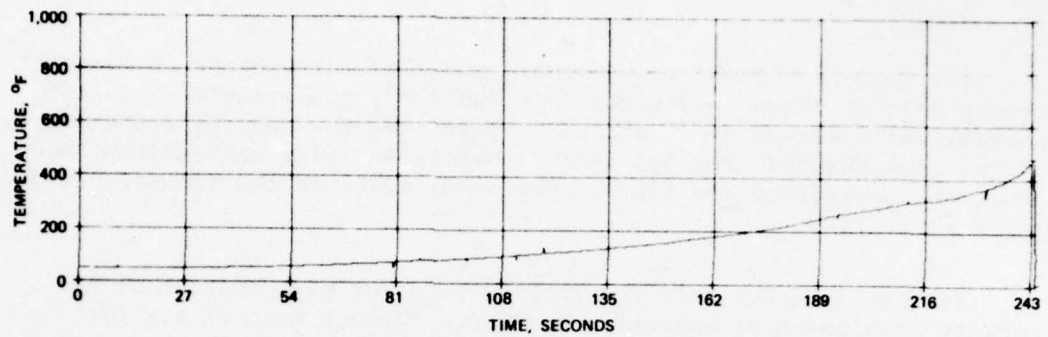
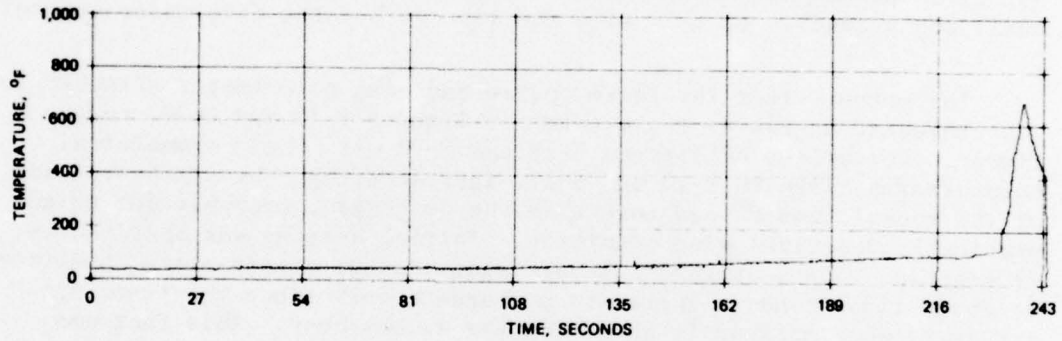
FIGURE E-16. Response of Thermocouple on Port Access Door.

FIGURE E-17. Response of Slug Calorimeter on Port Access Door.

The response of the thermocouple and slug calorimeter on the port access door is shown in Figures E-16 and E-17, respectively. Initial heating was detected at 27 seconds. Note that the melting temperature of the aluminum skin was not reached before the fire was extinguished. Also, no appreciable cooling was detected, although the firemen had just put out the fire.

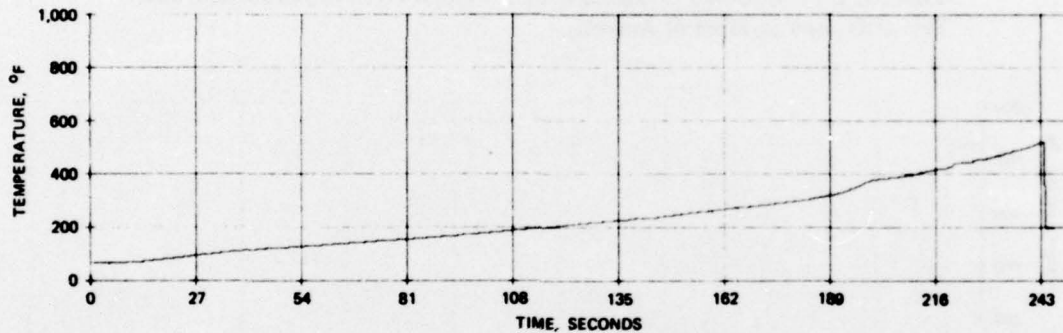
A thermocouple was placed behind the instrument panel in the forward bulkhead region with a direct view of the sky through the glareshield access hole. Its heating response is shown in Figure E-21. Initial heating was recorded at 8 seconds. Its heating rate was reasonably constant at 1.2°F/sec (0.67°C/sec) until 162 seconds. The observed hump, which is related to canopy failure, is detected in the 195-second time domain.

On the basis of the above data, in all probability no open fire existed in the forward bulkhead region until the canopy failed at 192 seconds. This conjecture was substantiated by post-test inspection of the dissected cockpit in that no charred paint or extensively burned components were found.

FIGURE E-21. Response of Thermocouple Placed Behind Instrument Panel Near Forward Bulkhead and With Direct View of Sky Through Glareshield Access Hole.

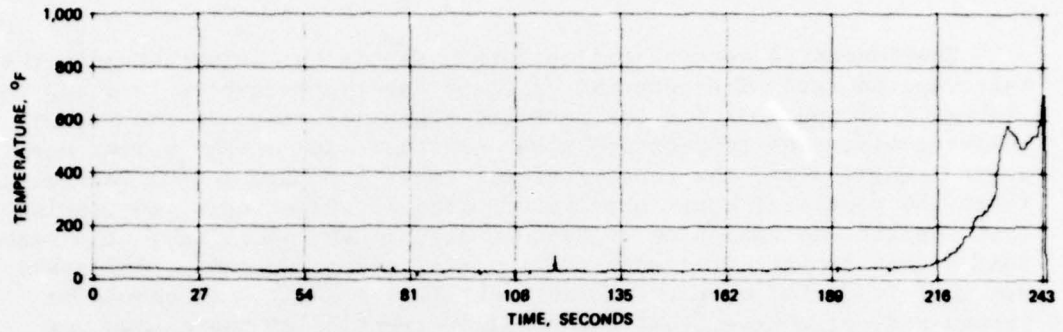
A thermocouple was attached above the glareshield alongside the exposed glass ferris wheel containing the cockpit mouse. The response of this thermocouple is given in Figure E-29. Heating in this location began at 211 seconds. Further confirmation of the relative coolness above the glareshield was provided by the thermocouple placed near the port and starboard panels as shown in Figures E-30 and E-31. The region above the glareshield apparently remained cool until after the canopy failed. This conjecture was confirmed by post-test inspection of the glareshield. Hence, it is probable that the cockpit mouse expired after the canopy failed.

FIGURE E-29. Response of Thermocouple Attached Alongside Glass Ferris Wheel Above Glareshield.

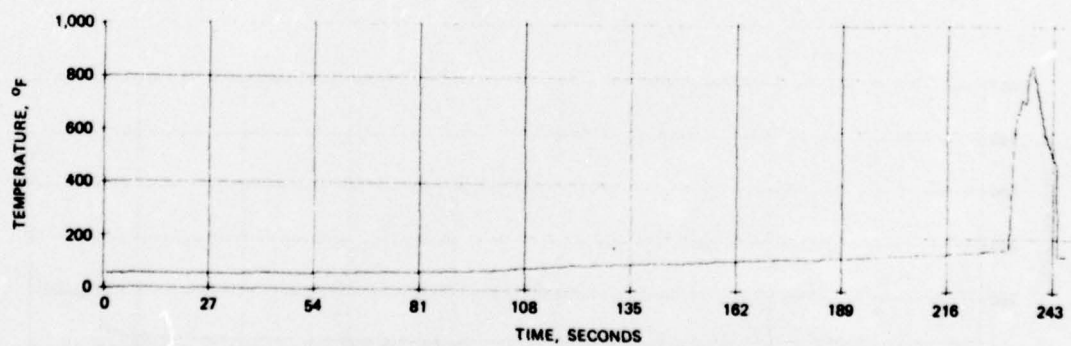
A thermocouple was also placed aft of the pilot's helmet. Its response is shown in Figure E-35. This thermocouple recorded a definite steady rise in temperature from about 27 seconds. At the time of canopy failure it had reached 127°F (51°C). This temperature rise is greater than that of other thermocouples in the vicinity, probably because it was in the air rather than being attached to the helmet. The temperature rise may be due primarily to free convection and not to fire radiation.

FIGURE E-35. Response of Thermocouple Placed Behind Pilot's Helmet.

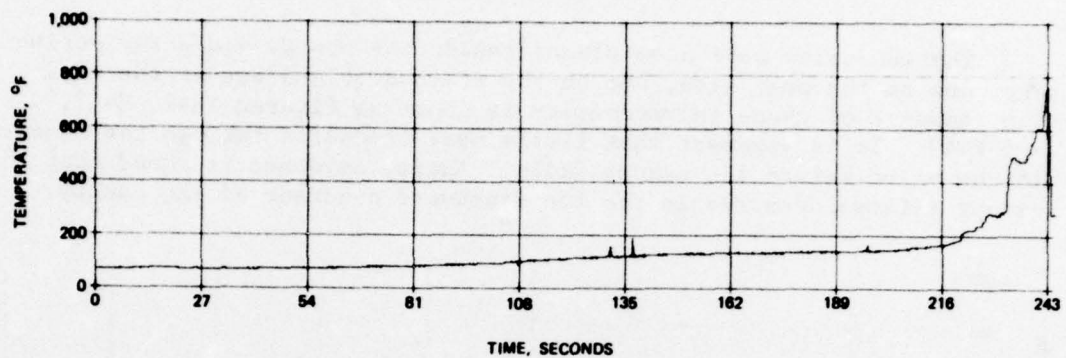
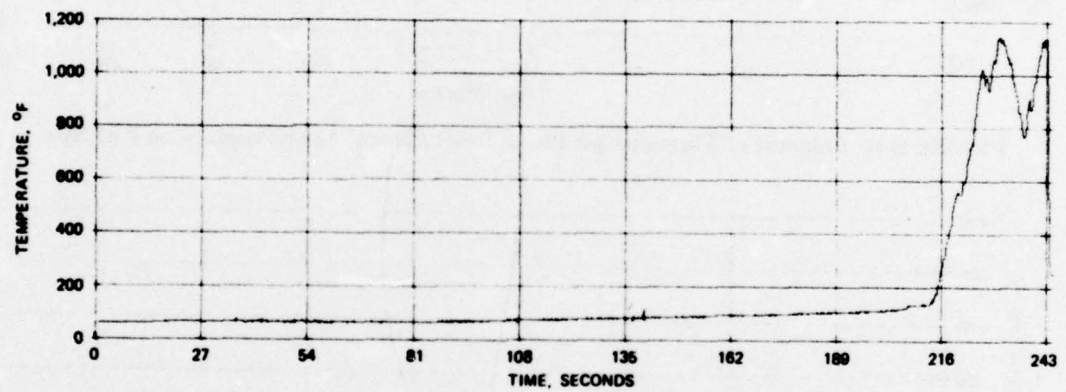
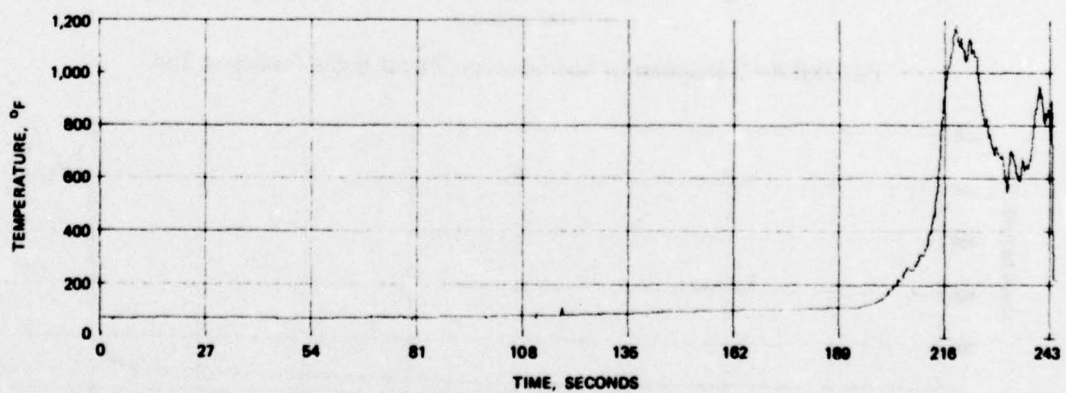
Thermocouples were attached to screws on the inside of the forward metal rim holding the leading edge of the canopy. The response of those thermocouples for the port, top, and outside regions are shown in Figures E-38, E-39, and E-40, respectively. Again, heating is shown not to be significant until after the canopy fractured. The relatively high heating response after the canopy failed suggests that the fire already existed forward of the pilot (manikin), as confirmed by the movie camera in the manikin, but required the top venting to propagate inside. Fire penetrated the starboard top side of the canopy first, as confirmed by the movie,¹ thus providing the required vent.

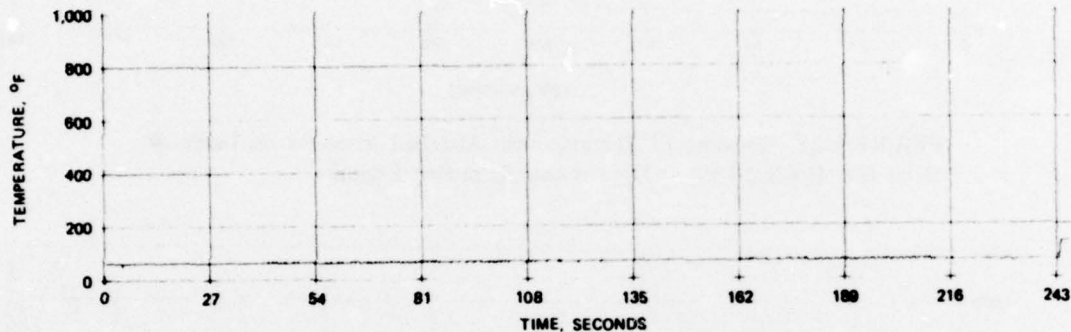
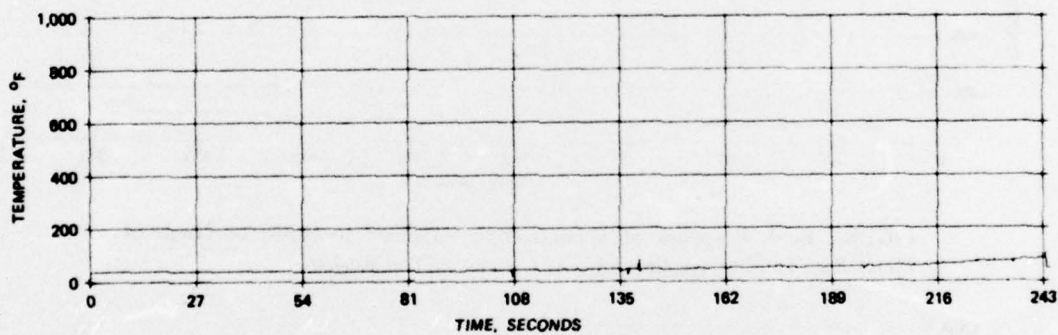
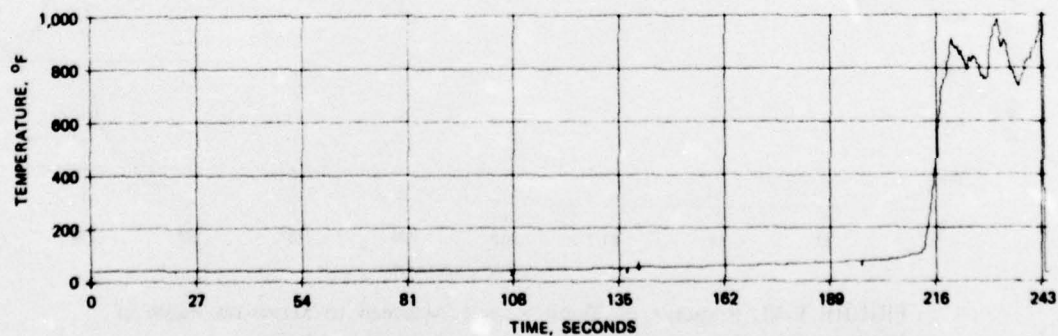
Thermocouples were also placed inside the canopy along the periphery; one on the port side, one on the starboard, and one at the top. The response of these thermocouples is shown in Figures E-41, E-42, and E-43. It is apparent that little heat transmits through the canopy to the pilot before the canopy fails. Again, evidence is found that the canopy failure occurred in the top starboard quadrant of the canopy.

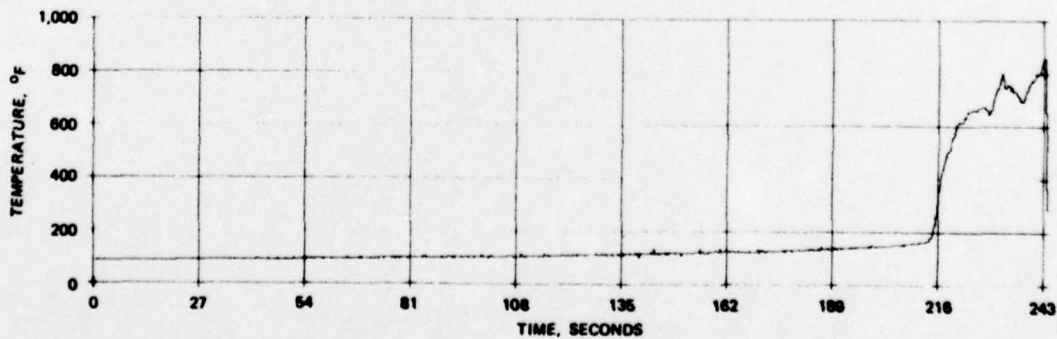
A thermocouple was placed on the pilot's seat above the aft floorboard. The response of this thermocouple is shown in Figure E-45. The heating begins at 59 seconds. The heating is due to fire in the wheel well eventually penetrating the floorboard and heating the seat from below. Post-test inspection revealed that the floorboard under the seat had melted and burned through. It is possible that this event contributed to or caused the anomaly in the development of toxic gases between 120 and 150 seconds that is discussed in Appendix F.

FIGURE E-45. Response of Thermocouple Placed on Pilot's Seat Above Aft Floorboard.

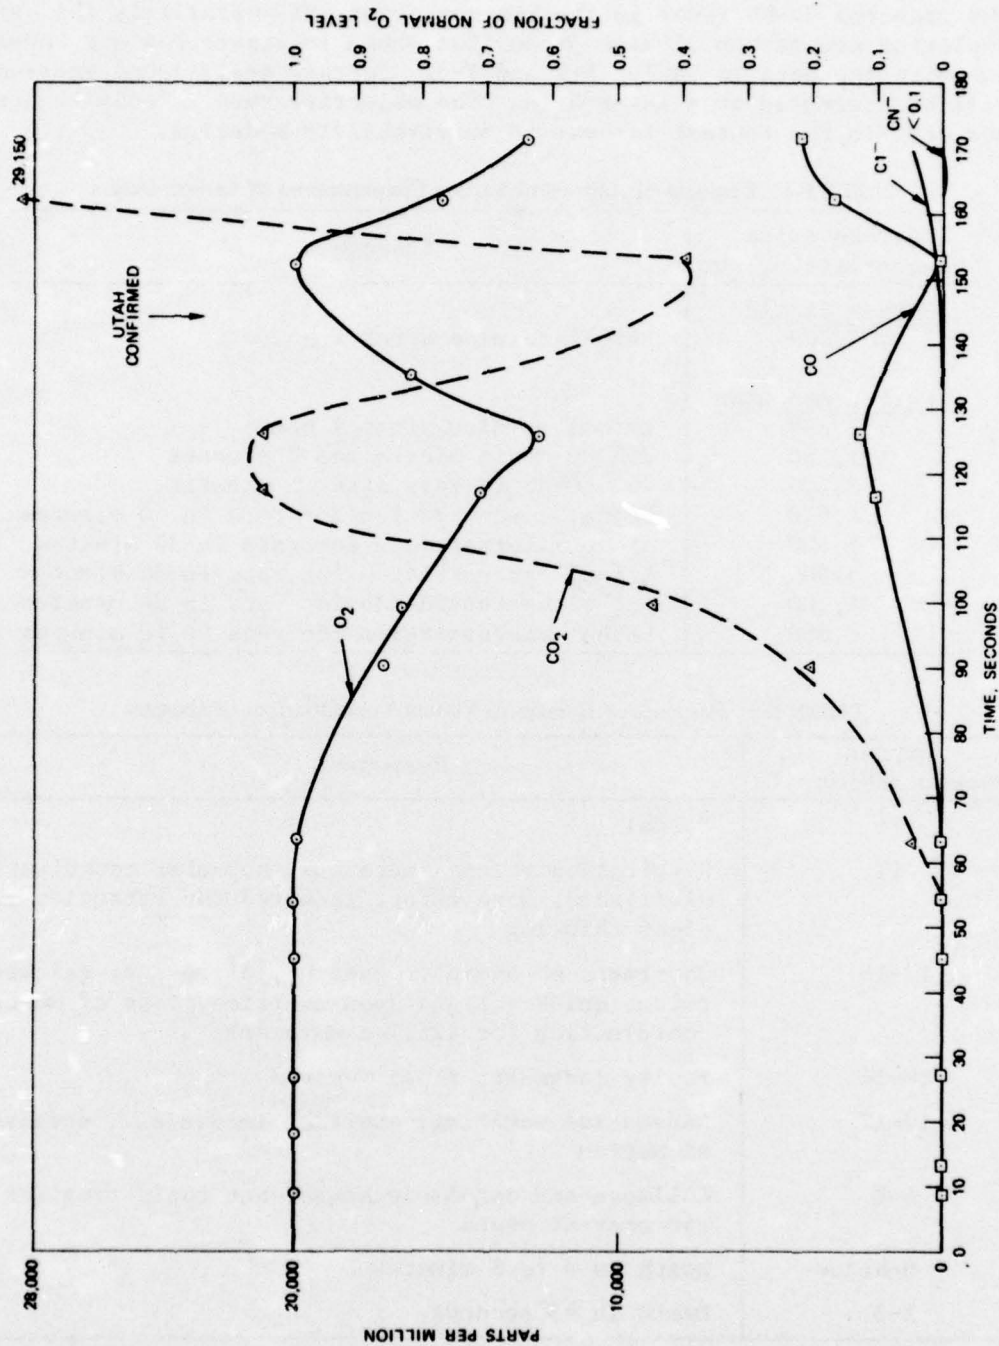
The results obtained from the analysis of the 15 gas samples are plotted in Figure F-6. The concentrations of oxygen, carbon dioxide, and carbon monoxide are shown, along with the concentrations of Cl^- and CN^- ions as indicated by the output from the specific ion electrodes. Note that the initial production of carbon dioxide and carbon monoxide correspond with the initial depletion of oxygen at about 55 seconds. At about 120 seconds a peculiar reversal occurs, suggesting that air entered the cockpit. Then at 150 seconds the depletion of oxygen and the production of carbon dioxide, carbon monoxide, Cl^- , and CN^- resumes. The data from the Flammability Research Center confirm the peculiar reversal (see Table F-4). However, the cause of the phenomenon is open to subjective interpretation. Hopefully, this reversal will eventually be explained by the model to be developed using the data generated in this report and in subsequent planned experiments.

That the quantitative values shown in Figure F-6 are reasonable is supported by data on the carboxyhemoglobin levels in the rat and mouse (which is discussed in Appendix G). For example, the maximum concentration of carbon monoxide measured (at 171 seconds) was about 4,400 ppm for a short period of time. Tables F-1 and F-2 suggest that the data point is reasonable. Table F-1 shows a lethal concentration for rats as 60 minutes for concentrations of 4,650 ppm, and Table F-2 shows that the

FIGURE F-6. Plot of NWC Gas Analysis.

50% CO-Hb level is reached in minutes in rats for a CO concentration of 5,000 ppm. Note that it is reported under "Animal Test Results" that the measured CO-Hb level in the rat was about 49%. Similarly the oxygen depletion and carbon dioxide production shown in Figure F-6 are consistent with the data in Tables F-2 and F-3. Further analysis of these data will be presented at a later date. The objective here is only to present the data in the context for use in survivability modeling.

The only other toxic gas of nominal concentration in this test was hydrogen chloride (HCl). This gas can be produced by thermal degradation of polyvinyl chloride. If HCl is inhaled, the upper respiratory tract will be severely damaged and that damage could lead to asphyxiation and death (Table G-4). From this table it would appear that the HCl concentration in the cockpit should not exceed 1,000 ppm over long periods of time. Note that this level of concentration was being approached at 170 seconds (Figure F-6).

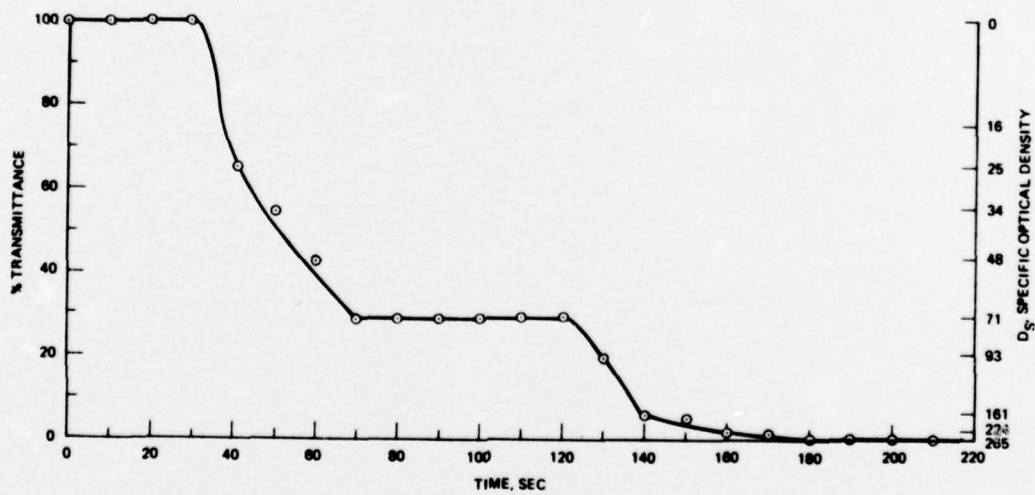
The output of the transducer during the A-4 burn test is shown in Figure H-7. No smoke was recorded until after 30 seconds into the test. At that time the transmittance began to decrease uniformly from 100 to 29% (from $D_s = 0$ to $D_s = 71$) at 70 seconds. The materials producing this smoke apparently were then expended, because the smoke transducer output remained uniform between 70 and 120 seconds. New smoke generation began at 120 seconds, causing the transducer output to decrease to $D_s = 161$ at 140 seconds. Complete smoke obscuration ($D_s = 200$) was measured by 155 seconds.

FIGURE H-7. Smoke Transducer Data Produced During Burn Test.

The transducer suffered fire damage before the fire was completely extinguished. However, because of its design, a few electronic components can be readily replaced to render the transducer operable again.

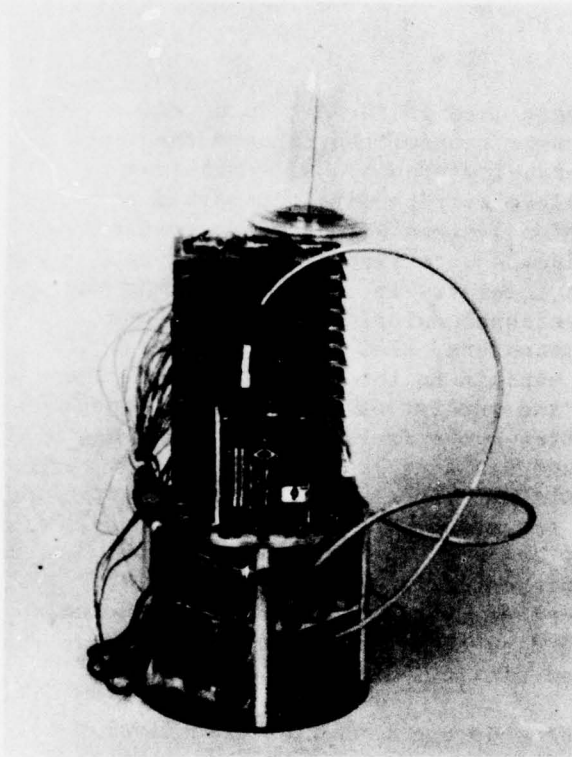
As a final note, the entire telemetry system except for the RF antenna (which may be seen on top of the transmitter in Figure J-1) was recovered after the test. It is thought that the antenna was broken by the force of the stream of light water used to extinguish the fire, rather than by the fire itself.

FIGURE J-1. RF Telemetry Transmitter. Item in glass cover atop the transmitter is the antenna, which was placed atop the fuselage behind the cockpit when the system was installed in the A-4. (Neg. LHL 186351)
